# BEEFING THE COMET AUTOMATIC

*Adding horsepower to the Comet/  
Falcon compacts makes these little  
bears real stormers, but a few minor  
changes in the transmission depart-  
ment are necessary to handle  
this new-found energy*

Photo Story by Eric Rickman

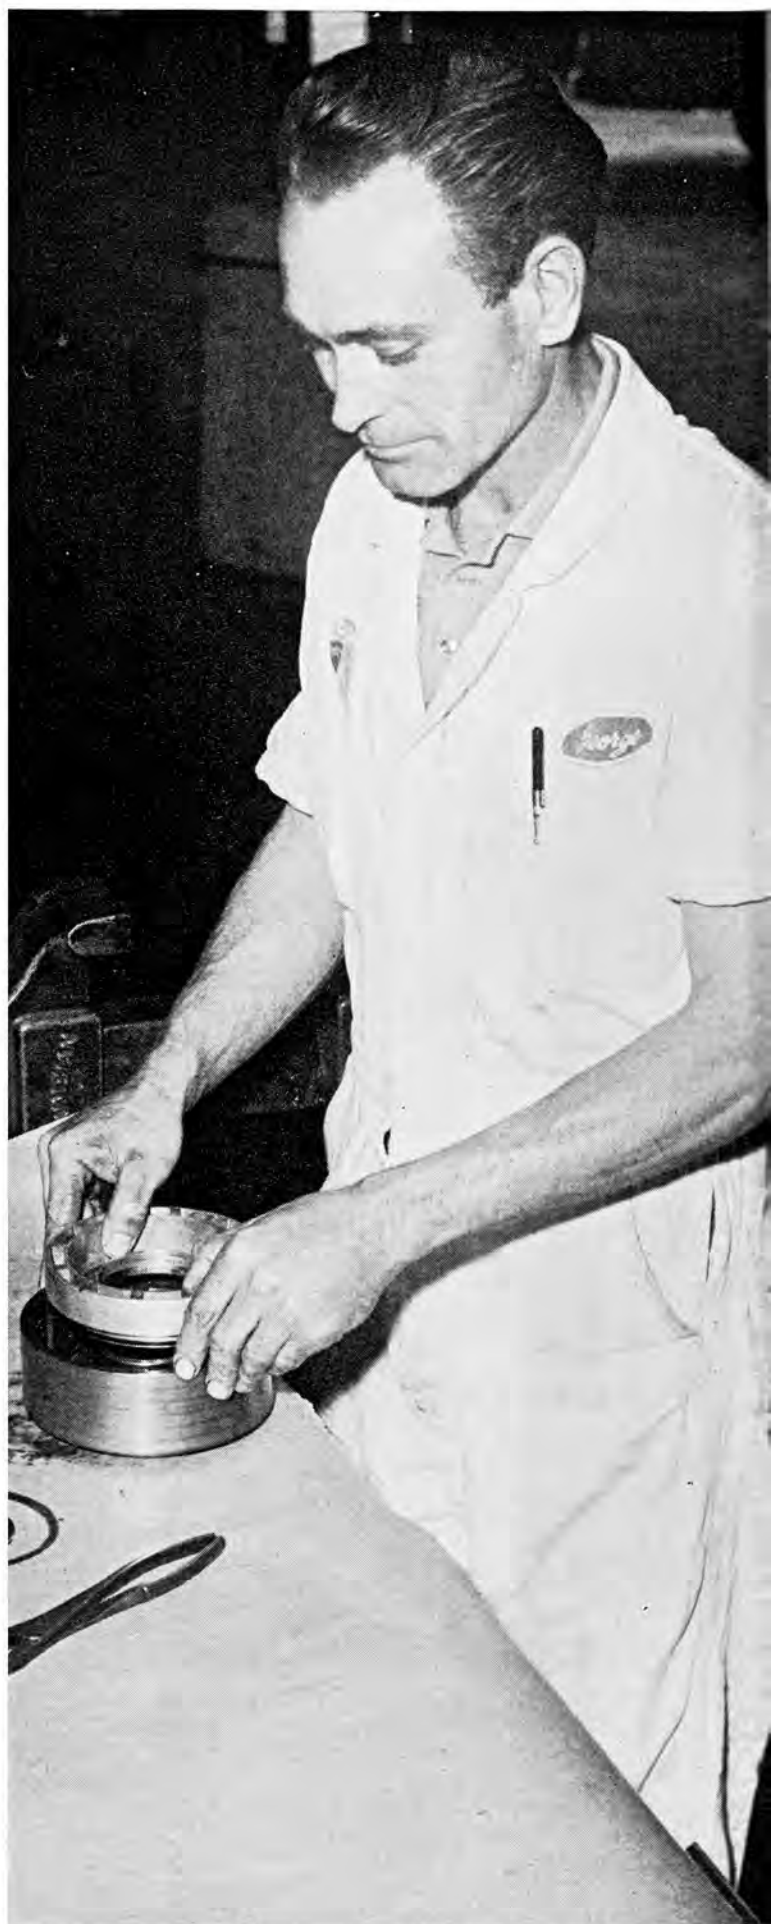
*RIGHT — Transmission expert George Crabtree removes thick piston from clutch drum. We recommend this part of job be done at your local transmission shop, as a special tool is needed to depress the heavy piston return spring safely. Snap ring and collar serve to lock piston and spring within clutch drum. Note very clean bench top. This is necessary.*

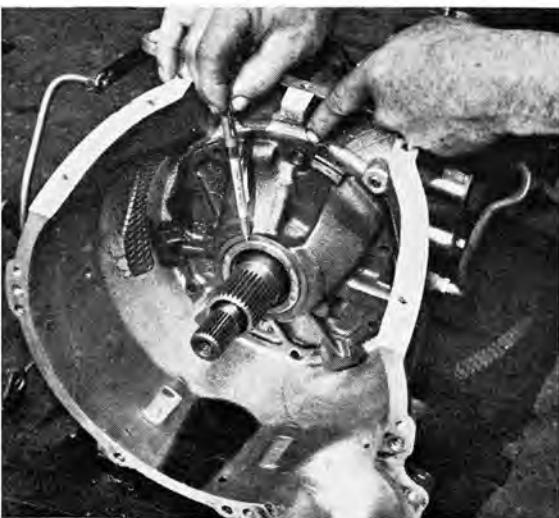
*LEFT* — To get at front pump assembly shown here, the torque converter slips easily off the splined shafts. This unit must be removed to get at the clutch drum. Pencil points out front seal which should be replaced. Finger indicates bottom screw which must be well sealed when the transmission is assembled.

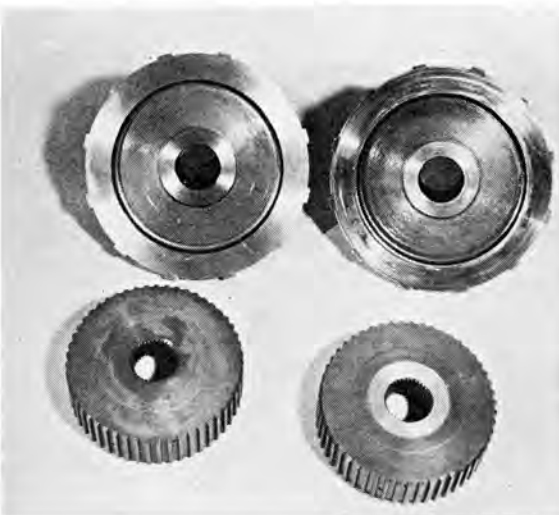
*LEFT* — Removal of large snap ring in sun gear cover permits disassembly of clutch drum. Top row left is new sun gear unit. Right shows a badly worn unit. Bottom row left is new clutch hub. Right, wear around shaft opening is quite evident here. Check closely for wear signs.

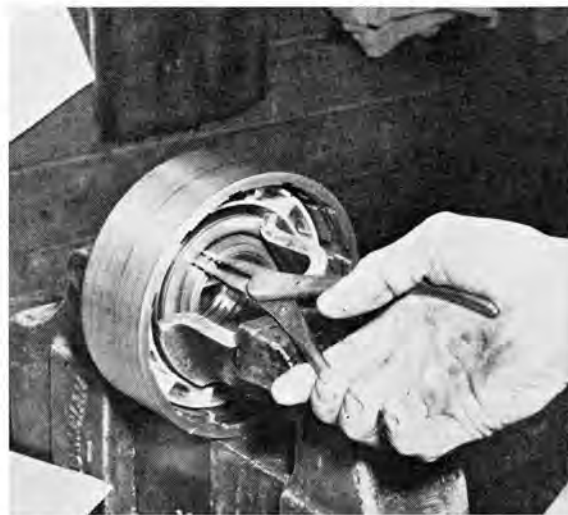
*RIGHT* — Removal of snap ring that holds piston return spring in place is accomplished using a special tool in bench vise to completely compress the spring. We made up a channel iron tool which served the same purpose.

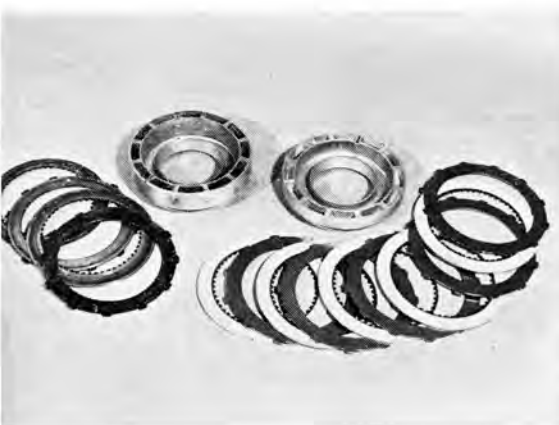
*LEFT* — An extra thick clutch piston with completely worn out set of clutch discs and plates appears on the left. New, thin replacement piston and the ten new clutch discs and plates are shown at the right. Be sure and alternate the discs and plates when stacking them back in the clutch drum. Note that steel disc goes against the piston face first.

our problem lay. With less car weight and horsepower to handle, the engineers decided to cut down on the number of clutch plates and discs in the compact transmission. The big car transmission utilizes five clutch discs and 5 clutch plates for a total of ten clutch units. The little one has only two of each. To take up the space left by the missing 6 clutch members the clutch piston was made thicker. Ergo! All you have to do to convert your compact transmission to a big car shifter is to install the thinner big car transmission clutch piston assembly, (part No. COAP-7A262-C) and install the five each clutch discs and plates that the big car uses, (parts No. Plate 77573, Disc 7B164). If you are

unable to obtain the proper piston and have a machine shop handy, you can chop the thick piston down to .447 of an inch and you're in business. Inspect the oil pump screen in the bottom of the transmission, and if any quantity of metal flakes is present you better have the trans completely checked over by an expert. He can replace worn parts when it goes back together. When making this conversion, a few words of caution; replace all seals that have been disturbed, and be very careful when reassembling not to damage any of the new seals. *Be clean.* The transmission will now engage a bit more positively, but since when did a hot rodder ever object to a good solid shift?

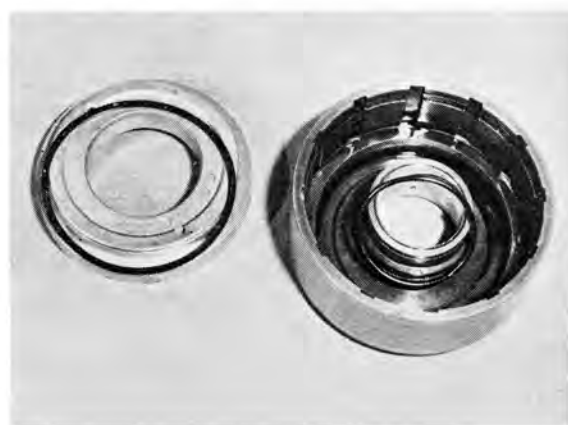
*RIGHT* — Both inner and outer piston seals shown here must be replaced. Bronze bushing in the clutch drum must not be worn.
