**A LITTLE CHEVY
MAKES A**

JEEP

**Here's a how-to-do-it
with a wallop:
327-inch Chevy V8
to Jeep bolt-in**

by Don Francisco

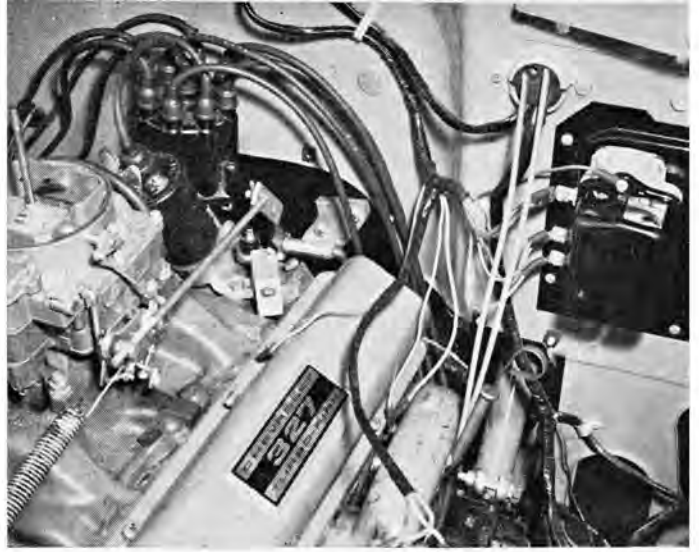
ABOVE RIGHT — Special bellerank for throttle linkage bolted to Jeep's floorpan. Mounting the Chevy generator regulator on the left side of the firewall enabled stock wiring to be used.

The throttle lever bellcrank included in the installation parts was bolted to the firewall so one of its levers could be connected to the rod from the accelerator pedal and its other lever would be in line with the carburetor's throttle arm. A rod was made to connect the carburetor to the bellcrank.

The Jeep's generator regulator was removed and one that matched the Chevy generator was secured to the firewall above and to the right of the steering gear column with sheet metal screws. With the regulator in this location, the Jeep's generator and regulator wires were long enough to reach it and the generator.

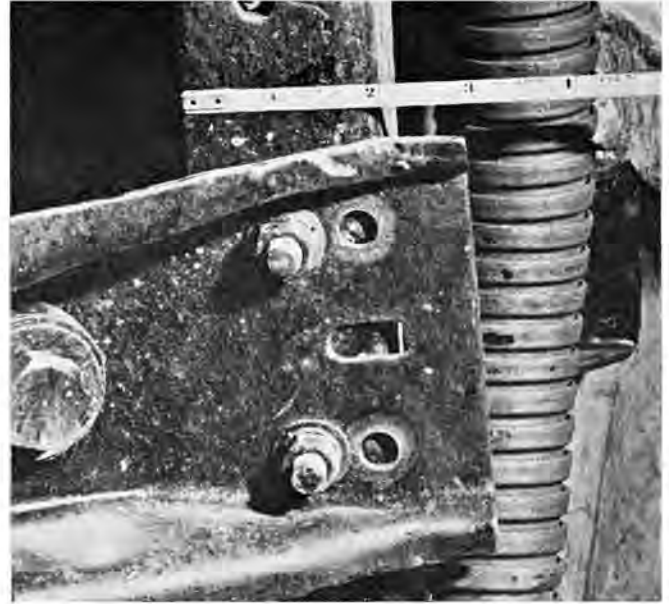
The distance between the bolts that secure the rear motor-mount crossmember's right end to the frame and their original holes shows how much the member was moved (about 3/4 inch) to provide clearance for the new engine.

pad at the left rear of the Chevy block for the full-flow oil filter and the pitman arm on the Jeep's steering gear, the engine couldn't be centered in the frame. The center of the crankshaft's nose was finally placed about 1¼-inch to the right of the frame's longitudinal center line and the rear crossmember was moved to the right approximately ¾-inch. New holes were drilled through the crossmember's right end to match the holes in the frame's lower flange. One new hole was drilled through the crossmember's left end to match one of the holes in the frame and another hole was drilled through both the crossmember and the frame. The crossmember was bolted to the frame with the original bolts and nuts.

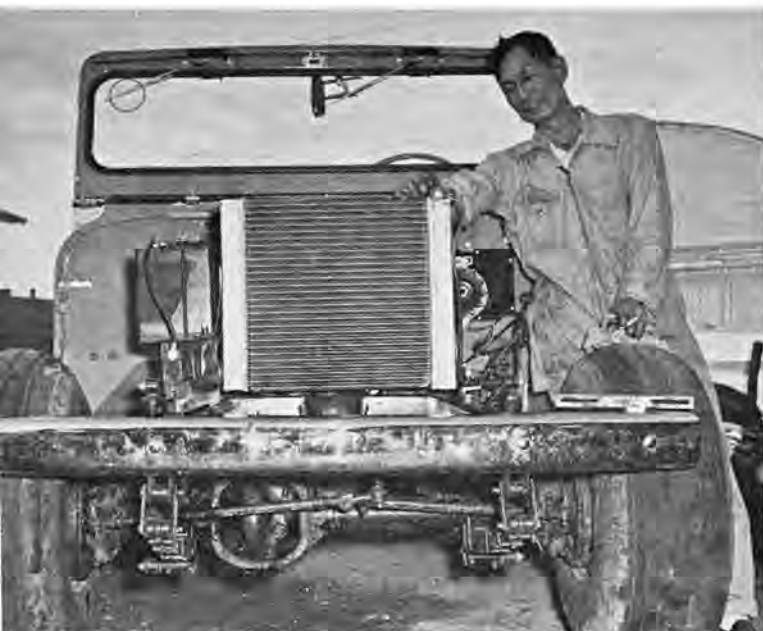
The radiator was built by Dyke Kagihara, left, who runs a radiator repair shop in Honolulu. As the radiator cooled the Chevy without any problems, Dyke had reason to be proud of his work. With the exception of the steering gear and its linkage, shown at right, a Jeep engine compartment has enough room for almost any automobile-type V8. Because of the way it is mounted, the steering gear is difficult to move. For the Chevy installation the engine was moved instead and the oil filter left off.

The Jeep radiator, which was supported by a flange on the rear face of a shroud that was part of the Jeep's grille assembly, couldn't be used in its stock location because it would have interfered with the front end of the engine. It couldn't have been used even without the shroud because it would have had to be mounted directly above the frame's front crossmember and this would have raised it so high that the hood wouldn't have closed. We weren't hot about using the Jeep radiator anyway because it didn't appear to have enough capacity to cool the Chevy.

To provide oil filter clearance, the steering gear pitman arm is heated and bent to move the drag link away from the engine. Bending a pitman arm is risky business unless the job is done by someone who understands metal and its limitations, and even then I don't recommend it. If done incorrectly the arm may be weakened to the point where it will break during normal use. This could cause a serious accident.

A 1949 Chrysler New Yorker straight-eight radiator core that has been shortened 4½ inches is used. This core has a large number of fins per inch and does a good cooling job. It is placed as far forward as possible, almost against the headlights, after the complete shroud has been removed from the grille. This location gives ½-inch clearance between the radiator and the fan, which so far has been enough. Dale and Paul use a four-blade fan but some fellows use a five-blade type made for an air-conditioned Chevy or Cad.

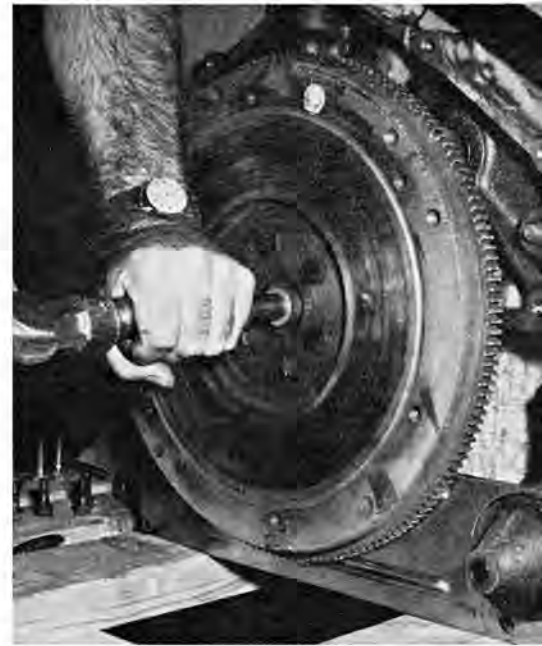
TOP — After removing standard pilot bushing from the Chevy's crank, the special bushing for the Jeep transmission, which was supplied with the adaptor equipment, was driven into place.

The Chevy pilot bushing was replaced with the special bushing without any difficulty but when the engine, adaptor, and transmission were bolted together we found that the adaptor was too thick for the Jeep transmission's clutch shaft length and the clutch shaft's splined portion was too small for the opening in the Chevy clutch disc. After examining different clutch shafts that matched the Chevy disc and were the correct length (but had a different gear and bearing diameter than a shaft that was supposed to be the same as the one in the transmission) another transmission with the correct shaft was found in Von Hamm-Young's parts department. The number of this transmission was 93033. It was a three-speed, the same as the one in the Jeep, but it was for a six-cylinder Jeep station wagon. It replaced the original transmission without any modifications and the adaptor and Chevy bellhousing bolted to it perfectly. However, before the Chevy could be positioned in the frame, the battery box, which was welded to the right frame rail, had to be removed. This was done with a cutting torch.

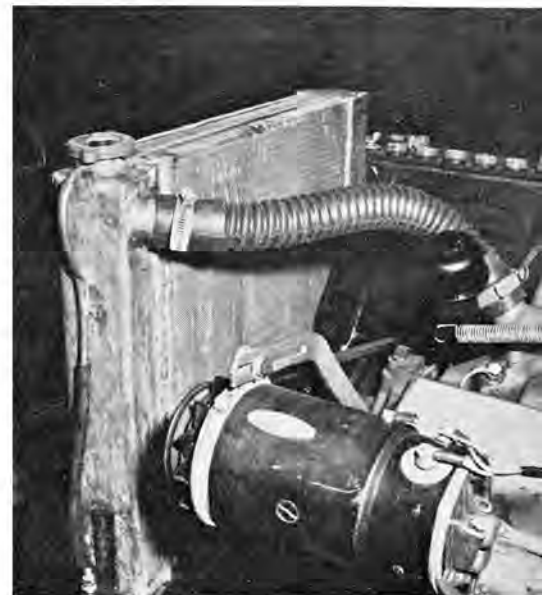
CENTER — Because Chevy engine was longer than Jeep engine the only place for radiator was over frame's front crossmember. This created clearance problems between radiator and hood that were solved with special radiator.

Dyke Kagihara, who has a radiator shop in Honolulu, made a new cross-flow radiator that could be mounted on top of the crossmember and allow the hood to close and that was as wide as restrictions in the engine compartment allowed it to be. The radiator was 2½ inches thick. Suitable fittings were provided in its tanks to match the fittings on the engine and it was connected to the engine with flexible hoses. It proved to be entirely satisfactory.

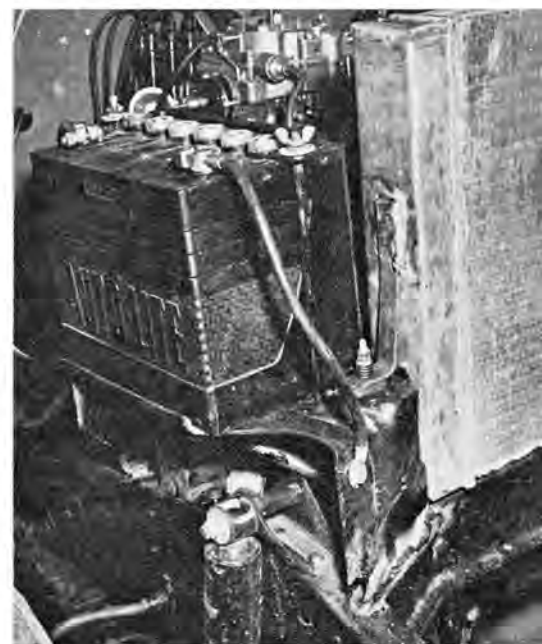
BOTTOM — Radiator was supported by brackets soldered to its tanks. The battery support was lowered to provide engine clearance and rewelded to the frame close to its original position.

To provide clearance for the radiator, the shroud on the rear of the grille assembly was shortened by removing a section approximately 5 inches wide from its rear end. The cut was made in line with the rear end of the reinforcing member on the shroud's lower side. Brackets soldered to the radiator's tanks supported it on the frame and a flange soldered to its upper surface was secured to the top of the shroud with sheet metal screws.

The battery box's brackets were shortened to lower the box so it would clear the engine and rewelded to the frame to place the box in approximately the same fore and aft position it occupied before. The Jeep's battery ground cable was connected to the engine and the other cable was connected to the battery post on the Chevy's starting motor solenoid. The solenoid actuating wire from the ignition switch was lengthened to reach the Chevy solenoid. Another wire was made to connect the solenoid's ignition coil terminal with the coil side of the coil's resistor. The purpose of this wire is to conduct battery voltage from the solenoid to the coil when the starting motor is cranking the engine. By-passing the resistor in this manner increases the voltage in the coil's primary circuit and improves engine starting. The ignition circuit was completed by connecting the wire from the ignition switch to the battery side of the resistor.
