GET 467 CUBES FROM A 283 CHEVY

DICK DI BIASI, of De Bi's Enterprises, Madison, New Jersey, has tackled the difficulty of increasing cylinder bores with a refreshingly new approach. Instead of attempts to gain a meager .060 to .125 inches by boring, then running into weakened cylinder walls, he tackles the problem at its roots. The result is a 4.5/16-inch by four-inch stroke in a Corvette engine that retains the somewhat oversquare bore and stroke ratio of the modern engine and gains enough cubic inches to match its larger competition. Since cast iron offers far better wear characteristics than steel and is easier to weld to parent block material, Dick selected cast iron sleeves as the material for his new cylinders.

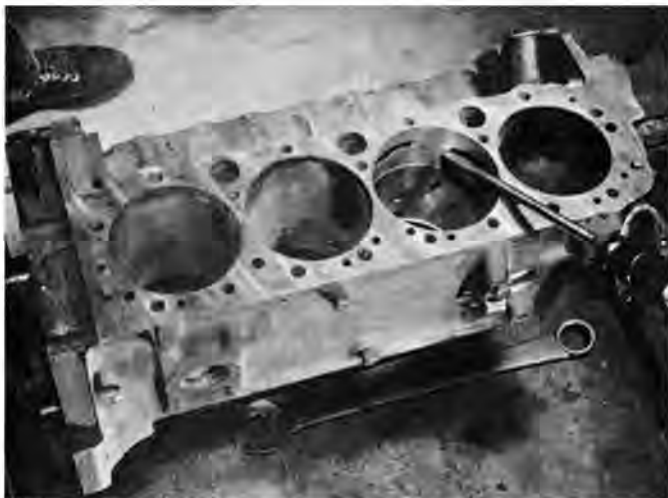
Use a screwdriver to remove the remaining sections. The cylinder walls' remarkable consistency of thickness is a tribute to Chevrolet's casting practice.

The block was set up on a stand and the existing cylinders were bored out until little more than "tissue paper" remained of the original stock. The remaining metal was then chipped out from the block, rather than take a chance on the boring bit catching and jamming. At this time, some bridge metal still joined the

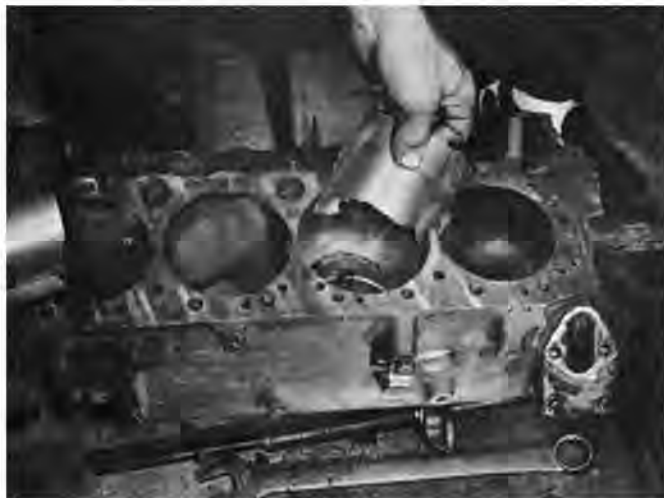
Stage one having been about completed, the cylinders have been almost completely removed. All that remain to go are the upper and lower decks.

sides of the upper and lower decks of the block. Additional cuts, in far smaller bites, were taken until the bores actually overlapped, leaving a cast iron outer shell in one cylinder bank.

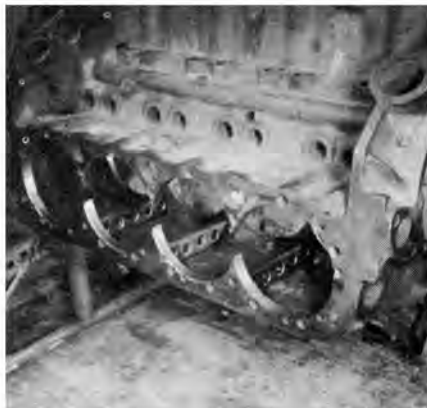
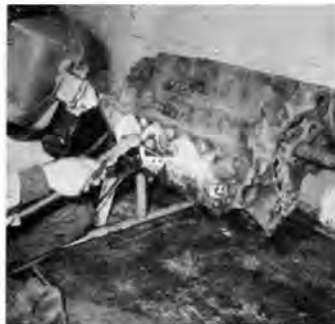
Arc weld the ribs on both sides of the block inside the block, using low melting point Eutectic 224 rod.

the use of a Eutectic 2-24 cast iron alloy rod which melts at a substantially lower temperature than the block itself. By welding only a small section at a time, heat was kept to a minimum . . . so much so that the block could be touched for an instant with a bare hand within five seconds of any pass with the rod. When the block became too hot for touch, it was allowed to cool back down to room temperature. The care certainly paid off since the casting shows no signs of internal or external "weeping."

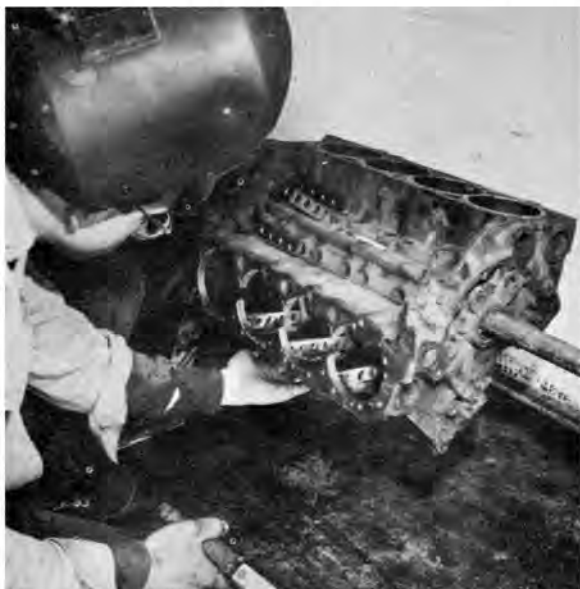
BELOW By welding short sections at a time, and alternating between the various ribs, you can keep the casting fairly cool. It can be touched with the hand within seconds after a weld has been completed. When the block's too hot, stop until it hits room temperature.

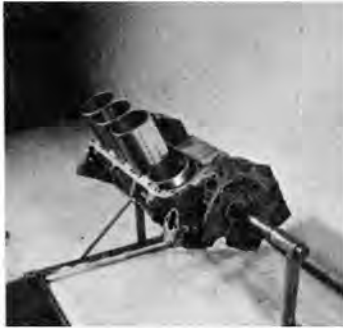
Now fit the sleeves into the block. The side of each sleeve must be milled where it connects to the adjoining cylinder. This offers a $\frac{1}{8}$ -inch gain in permissible bore size. The lower sections of the sleeves are also welded to the block. Then reinforcements are added at the main bearing webs where the boring bar has met them. Extra reinforcement must be added along the flange width.

ABOVE Completed block is about to go out for refacing and a final boring job. The cylinders are, for all practical purposes, siamesed. LEFT Resurfaced block is ready for final finishing such as facing decks, drilling, retapping holes.

We now come to the most controversial feature of the installation, a set of flats machined where the sleeves adjoin each other. This feature enabled Dick to gain a good 1/16-inch on each side or a 1/8-inch larger bore diameter, while retaining a large amount of meat in most of the sleeve. For its use as a competition engine, this design may be considered adequate and even ingenious. However, in an engine built for the street we call it a direct invitation to trouble. Engine builders strive to

After welding in the ribs, the cylinders were pushed into position. Beads around the tops and bottoms of the cylinders locked them inside the block and assured watertightness. Weld was also deposited in the cylinder head bolt holes affected by the boring operation. Only one side of the block was done at a time to retain maximum support and stability during machining operations.

A considerable amount of reinforcement was added to the main bearing webs, and new four-bolt main bearing caps were installed in the engine. As an additional precaution, the lower section of the block was refaced and the mains were line-bored. For maximum accuracy, the tops of the block were refaced with
