# Here's a technical tip sent in by one of our readers that will be of interest to . . .

Text and Photos by STAN STANTON

# CHEVY OWNERS only.

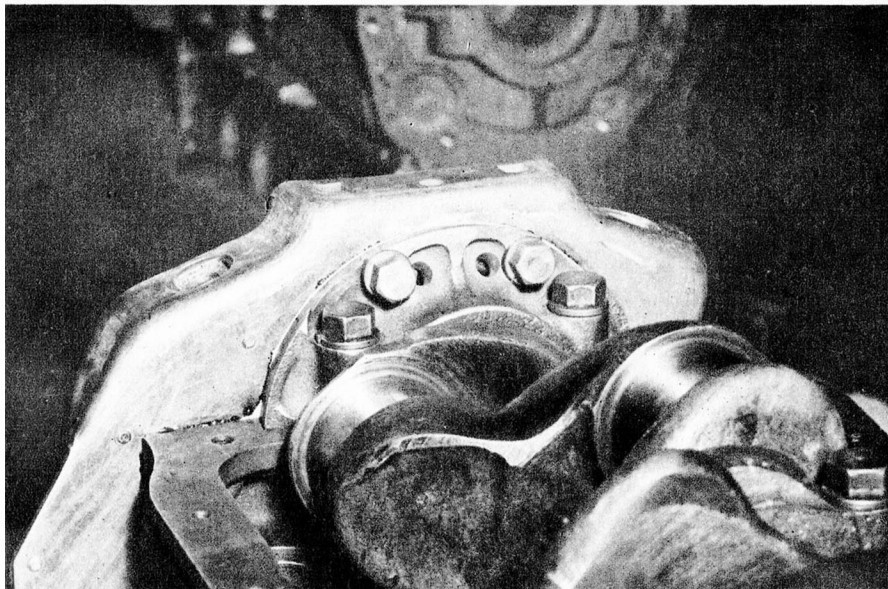
**Front view of Chevy engine showing positioning of newly located bolts**

**Step 5**—The  $\frac{5}{16}$ " tapped holes in the timing cover are drilled out to  $\frac{7}{16}$ " to allow for clearance for the new bolts you will use. Next, open up the  $\frac{5}{16}$ " holes in the main bearing skirt to  $\frac{7}{16}$ ".  $\frac{7}{16}$ " diameter by  $\frac{3}{4}$ " long machine cap screws are used in these holes to bolt to the motor support plate in place of the original  $\frac{5}{16}$ " cap screws. Refer to the photograph.

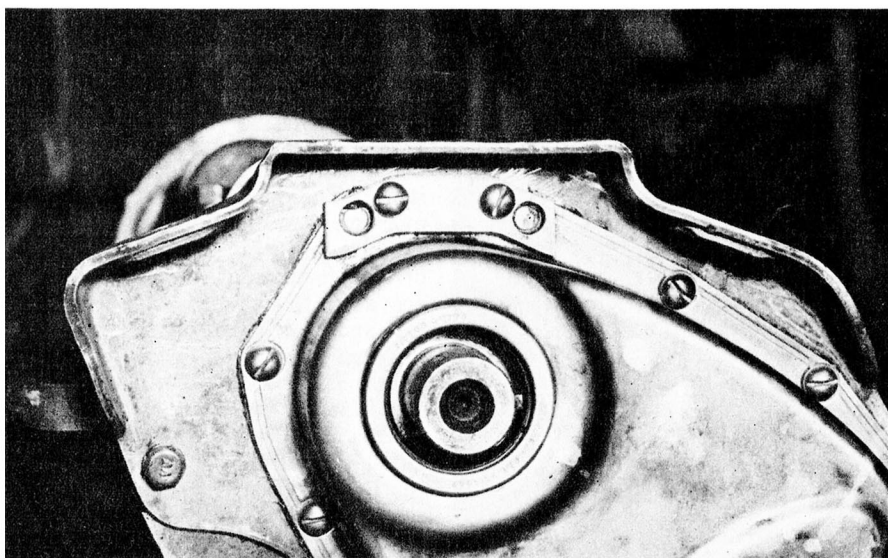
**Rear view of same Chevy alteration.**
