Customized Lincoln Capri receives annual reworking. This year's changes include wheel cutouts, new chrome, new paint.

# custom capri

# act 3

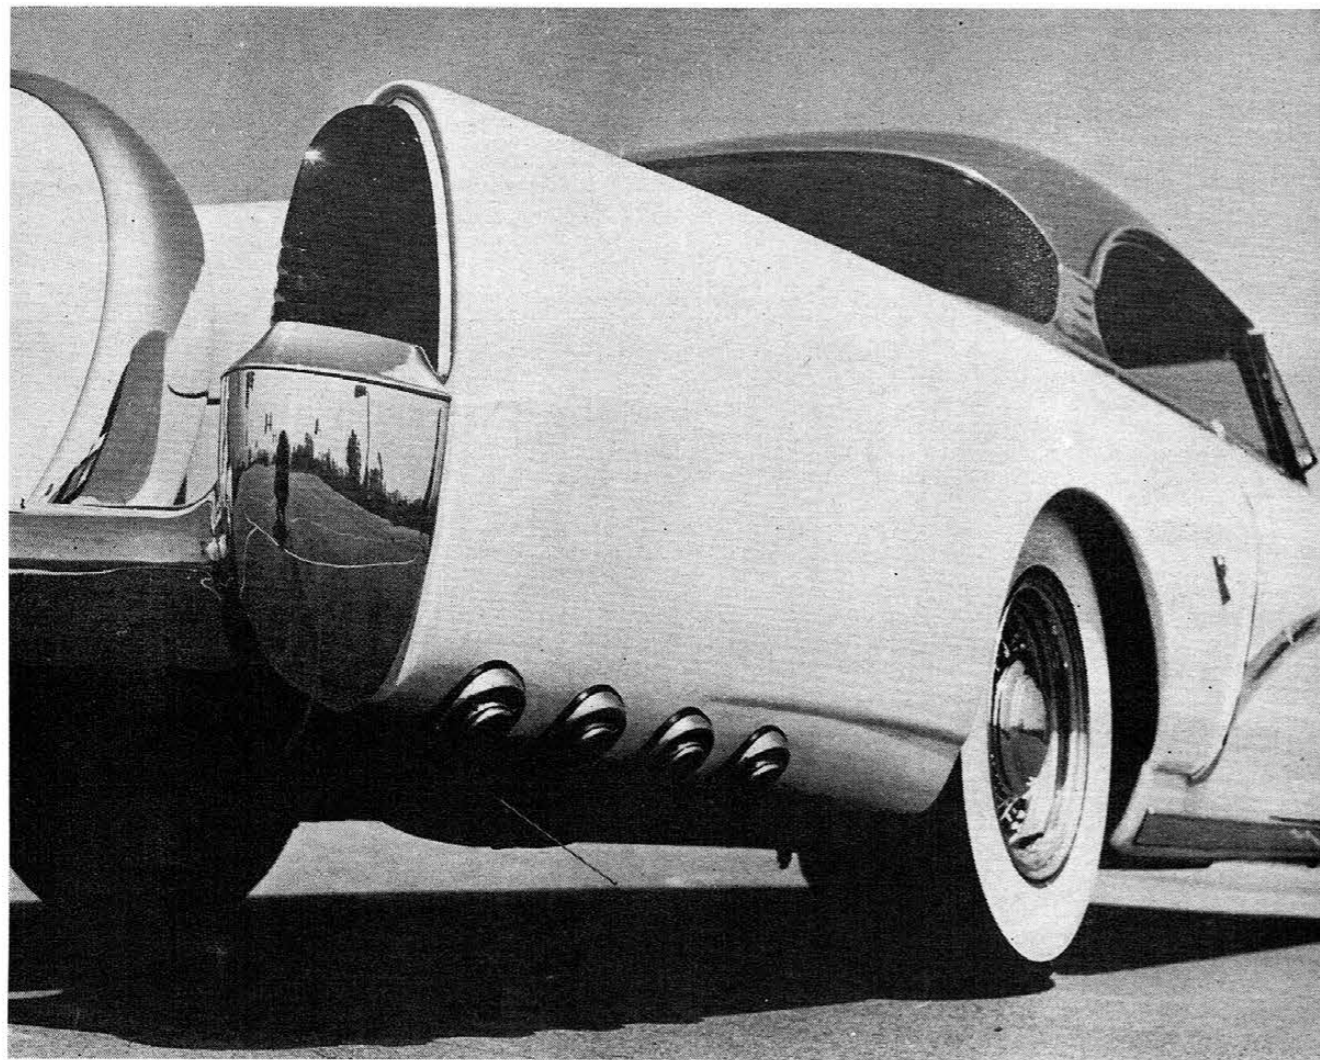
Most startling effect is the rear overhang. Fenders were extended twelve inches to encompass spare. Note exhausts.

ideas sketched by that owner. (See November, 1953, HOP UP). During that restyling stage, the Capri was nosed and decked, the bottom portion of the Lincoln grille-bumper assembly was cut, recessed three inches and painted and a Kaiser grille bar was added. Original rear fender chrome strips were removed and replaced with fake brake-cooling air scoops and the rear fenders, themselves, were extended twelve inches to encompass a continental kit addition. Each of the dual exhaust lines was split into four branch tips leading out of the fender bottoms through chrome rings.
